Manhole Inspection Summary

Manhole # S27K__026MH

Insp Date: **3/26/09 12:55 PM**

Location Address: **RYAN ST**

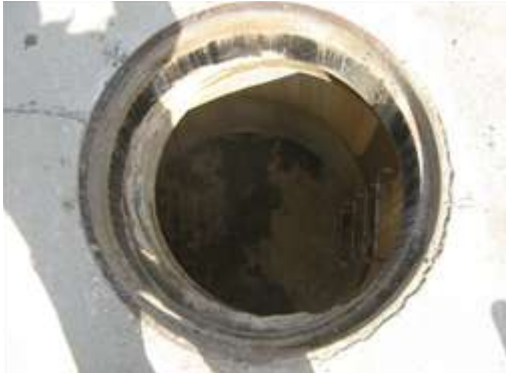
Defect 3

Offset: **2** (in.)

2 inch Offset visible in top view photo

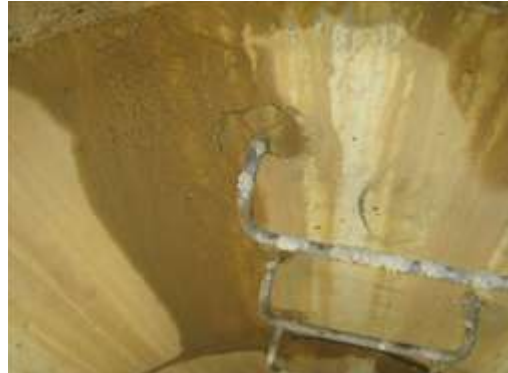
Defect 2

☒ **Leaks**

LID/FRAME INFILTRATION

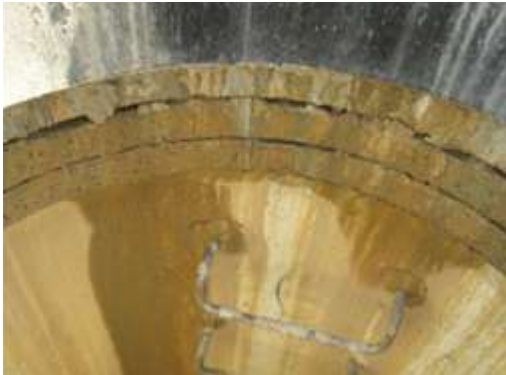
Defect 1

☒ **Mortar**

CHIMNEY JOINT INFILTRATION
MISSING MORTAR/LID/FRAME
INFILTRATION
